# Project Description

**Description:** *LUST Site Remediation*

**Site:** *Automotive Repair Facility*

**Location:** *Indiana*

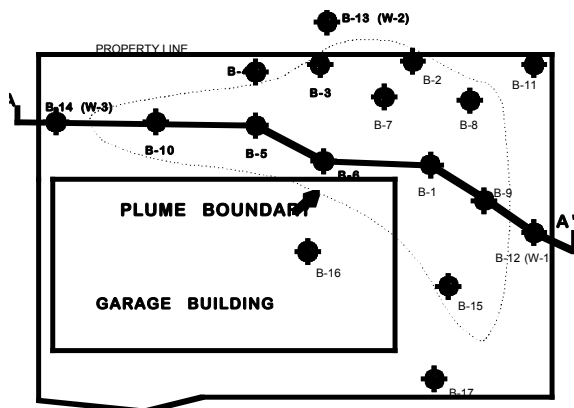
The owner of a local automotive repair facility removed his USTs from the ground. During removal, a substantial release of gasoline was identified. Following a detailed subsurface investigation, a plume of TPH impacted soil was identified as illustrated below:
