# Project Description

**Description:** *LUST Site Remediation*

**Site:** *Automotive Repair Facility*

**Location:** *Indiana*

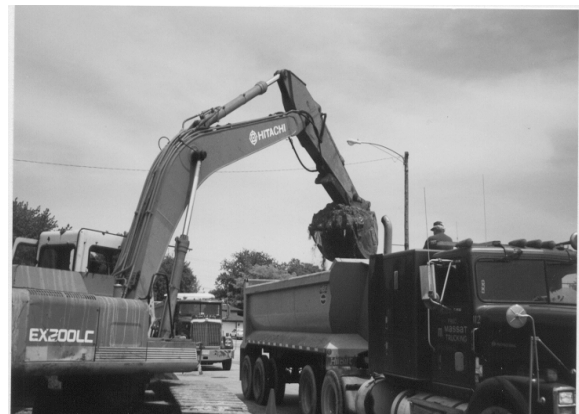
From the inception of the project, the stability of the facility structure was an issue. The state regulatory agency indicated that they believed sheeting and shoring would be necessary. By correctly staging the excavation in the vicinity of the building, IES was able to complete the work without sheeting or shoring, saving the customer considerable money. At the conclusion of corrective action, the site was restored and IES was successful in recovering 99 percent

IES was subsequently retained as the general contractor for the cleanup. Over an approximately 24 day period, IES excavated approximately 2,200 cubic yards of soil,

exporting approximately 820 cubic yards to a special-waste permitted landfill.
